**Helicopter Operations Task Force  
S-92A Return to Service Assessment**

**Final Report**

5 May 09

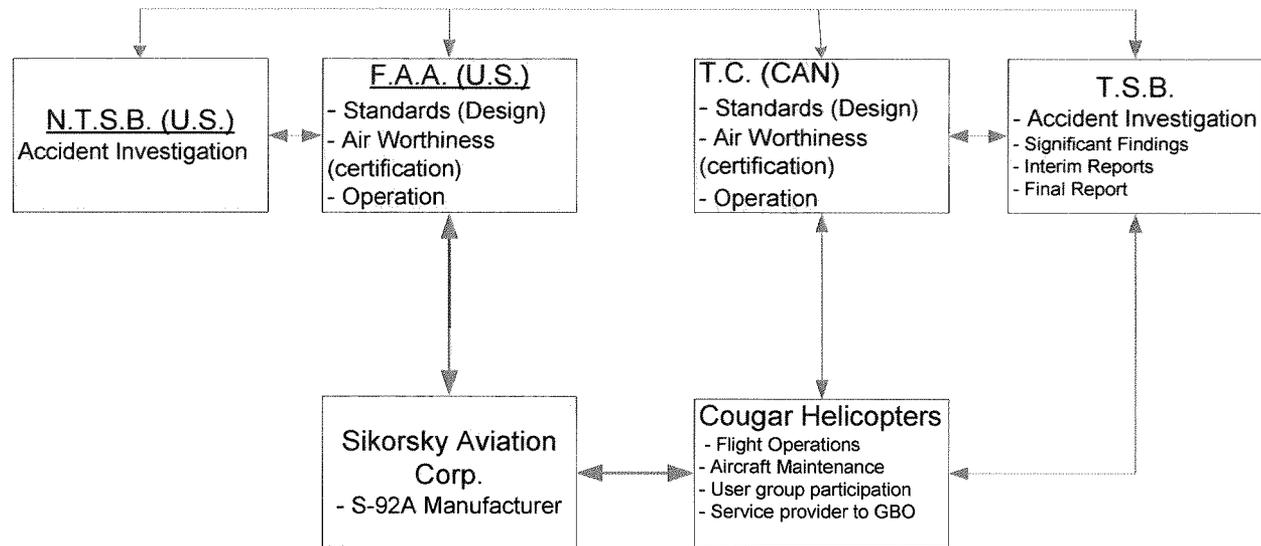
Figure 1. Aviation Industry Overview

As part of the stakeholder communications plan, a brief overview of the industry regulatory framework was developed. The S-92A helicopter was manufactured by Sikorsky Aircraft Corporation in the United States in accordance with FAA regulations. Certification of the aircraft in Canada is in accordance with Transport Canada Regulations. The TSB and NTSB are independent federal government bodies, in Canada and the US respectively, charged with investigation of aviation accidents. The following figure illustrates a simplified version of their interrelationships.
